# Single Survey

Property address	214 Hillington Road South Glasgow G52 2BB
Customer	Joseph Cumming
Customer address	214 Hillington Road South Glasgow G52 2BB
Prepared by	Shepherd Chartered Surveyors
Date of inspection	09/06/2025

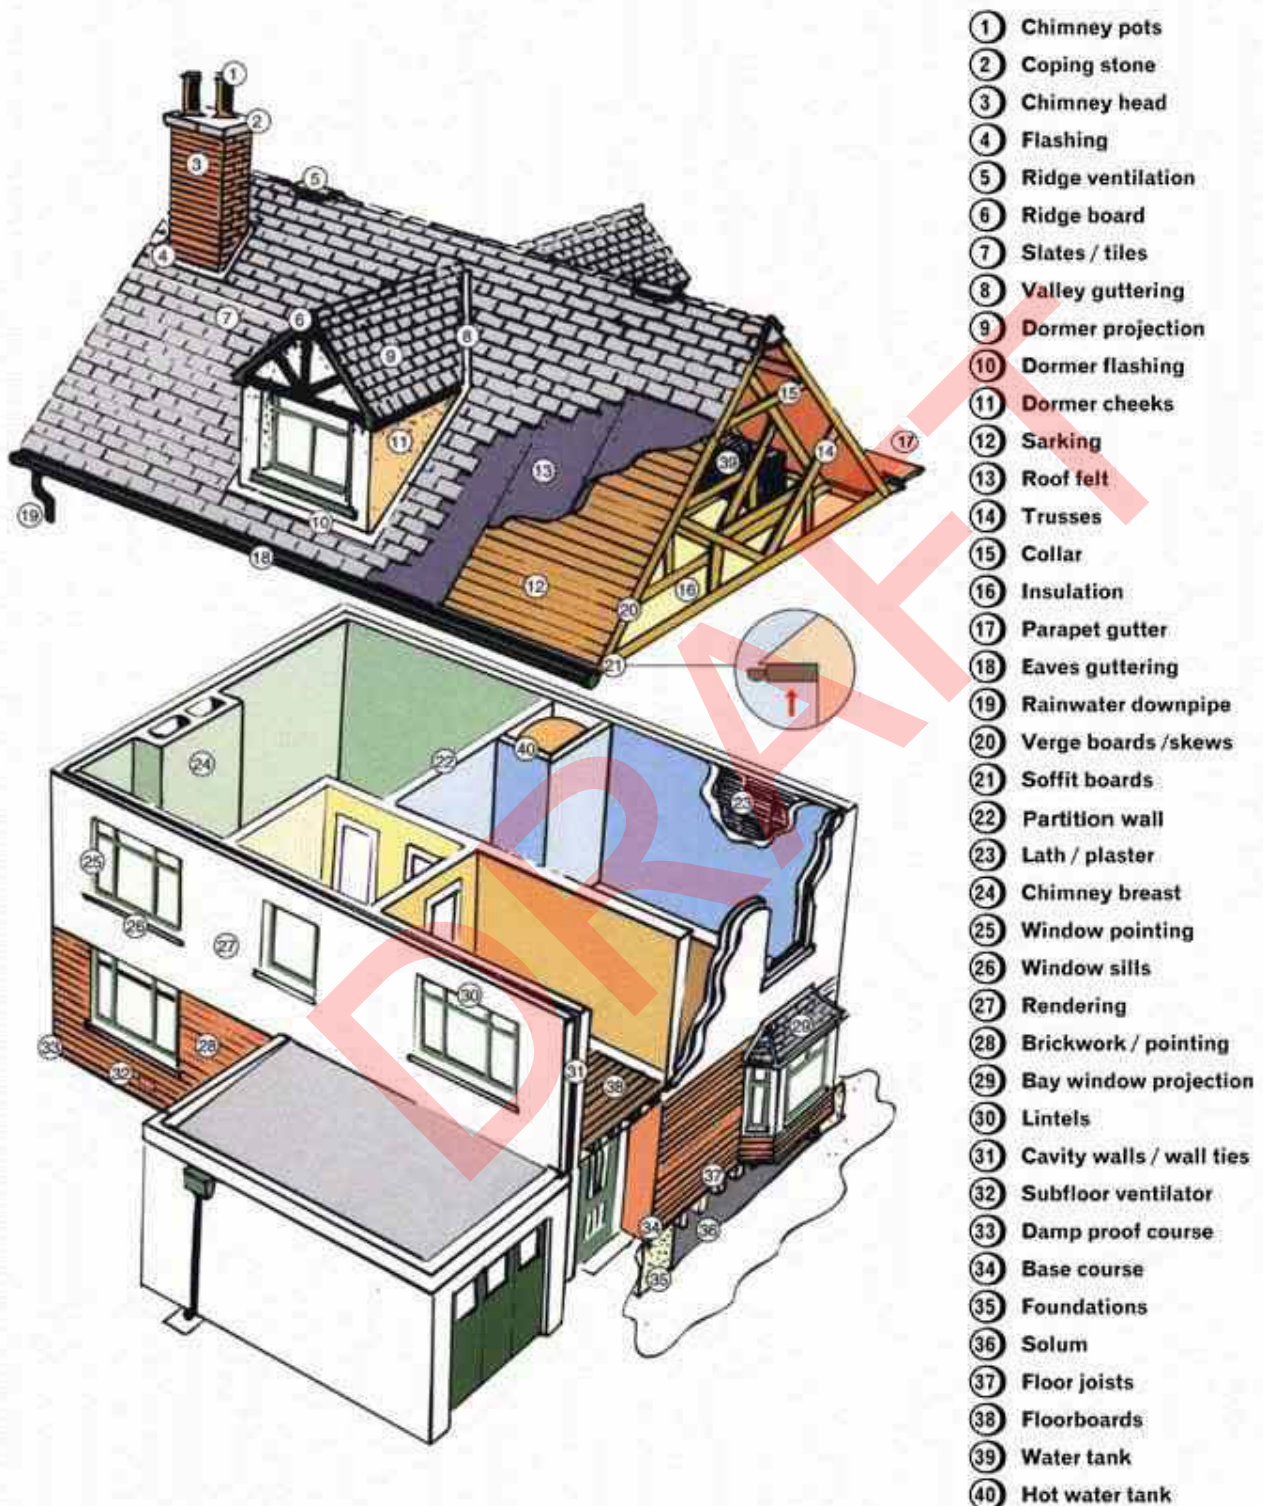
## Sectional Diagram showing elements of a typical house

Reference may be made in this report to some or all of the above component parts of the property. This diagram may assist you in locating and understanding these items.
